Vector 40R powerboat, contact with a navigation buoy

in Southampton Water

13 May 2015

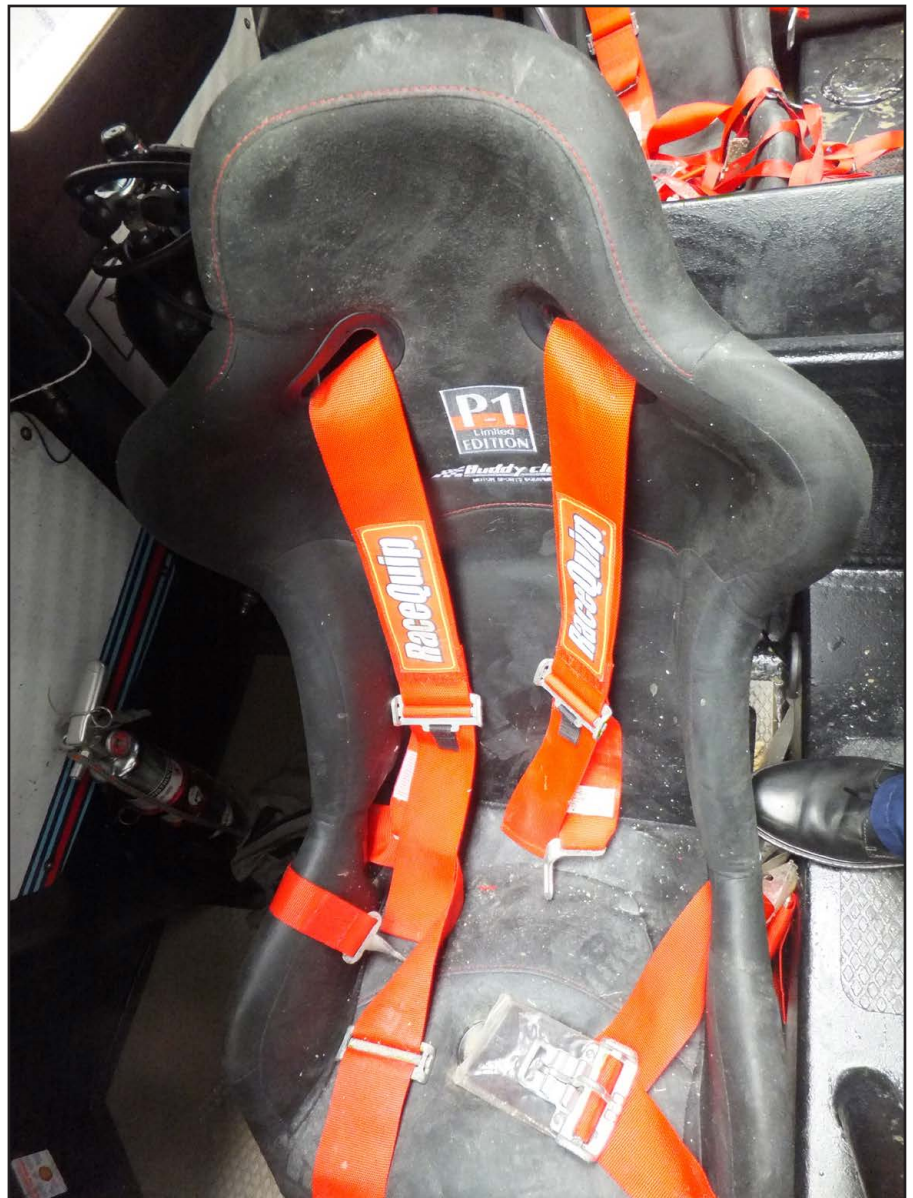
Figure 2: Harnesses (5 point) fitted to each seat

Travelling at high speeds during tests, or for the experience such rides provide, can exert forces on individuals similar to those experienced during racing. Had the boat been entered for a race, the use of harnesses and helmets would have been mandated by the race organisers: this requirement would have been well known to the driver and co-driver. The purpose of the helmets and harnesses is to help protect the boat's occupants from injury in the event of an accident. Had the crew and passengers of the Vector 40R been strapped in and wearing helmets during this accident, it is likely that their injuries would have been less significant.

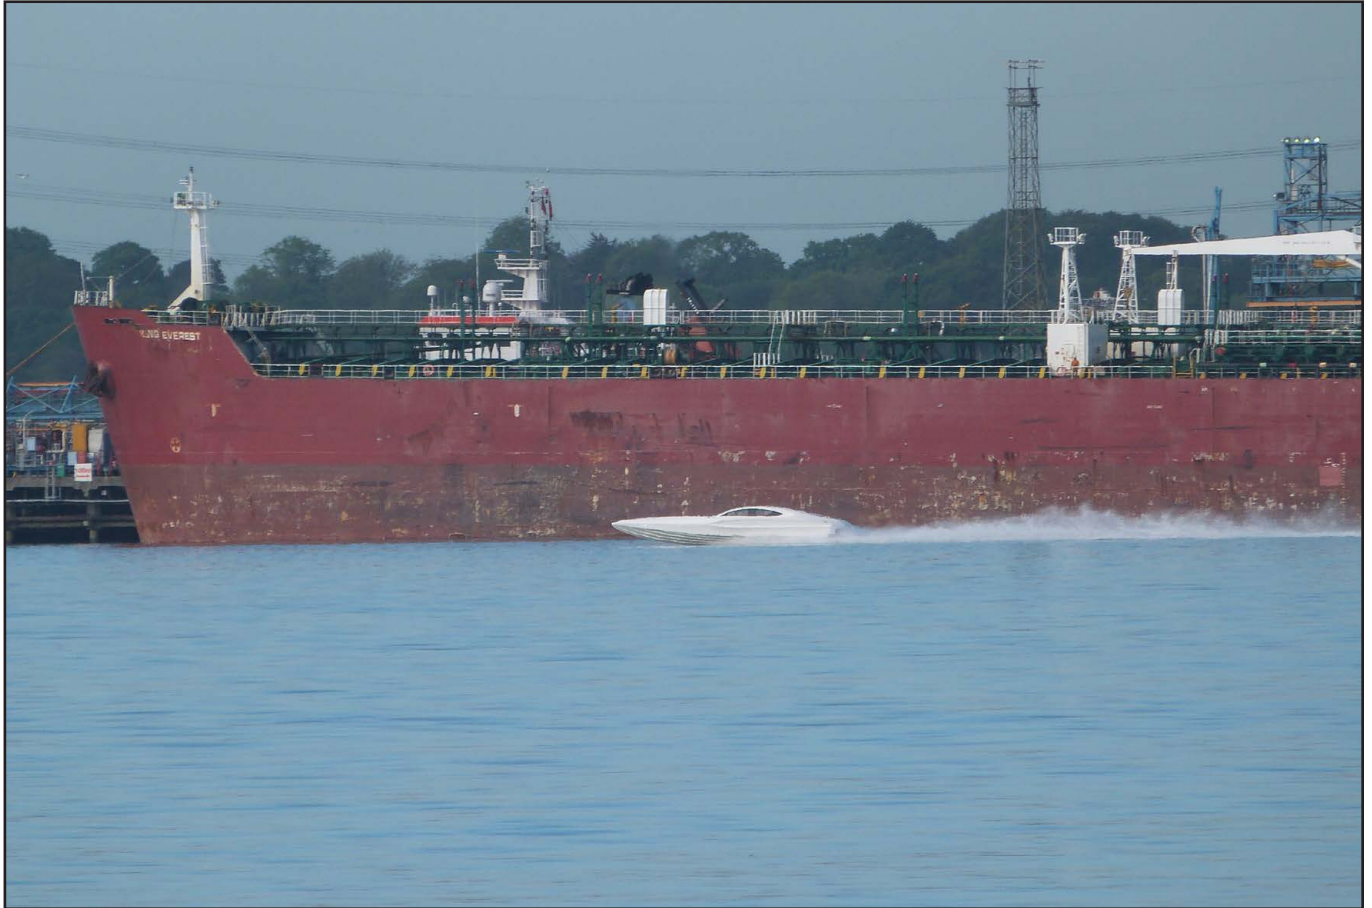
Figure 4: 100mph passing Fawley Marine Terminal

Off Netley, the driver turned the boat to starboard onto a south-easterly heading and increased speed. At 0815 it reached a speed of 87kts (100mph) as it passed the Fawley Marine Terminal (**Figure 4**).

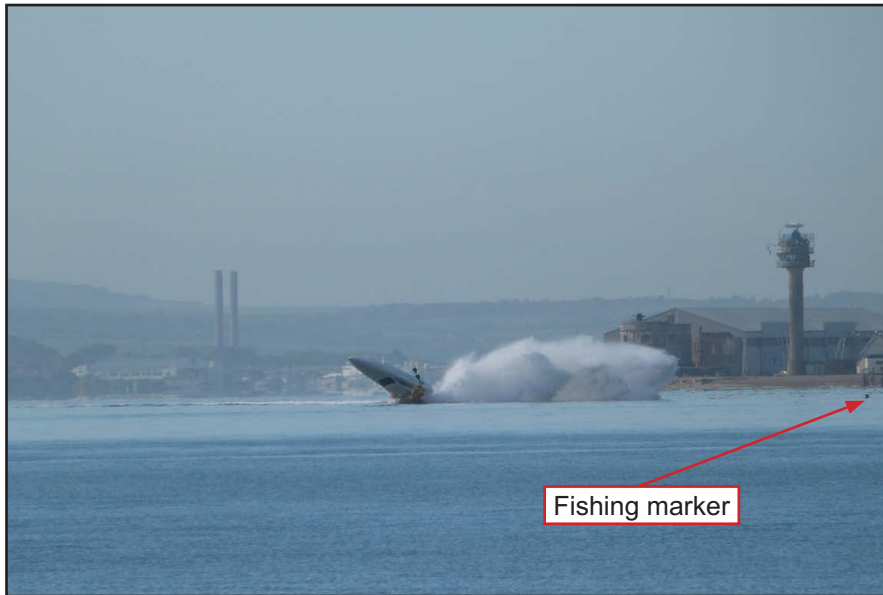
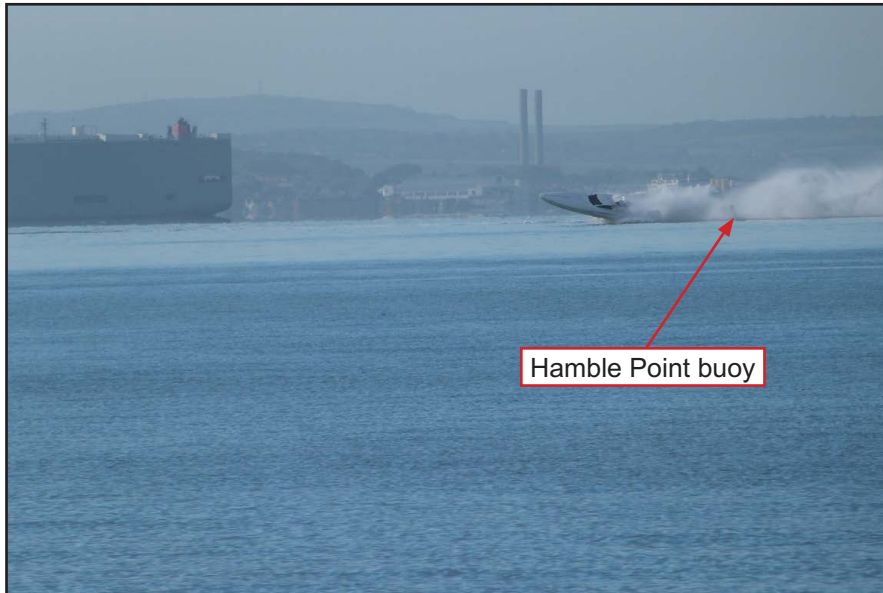
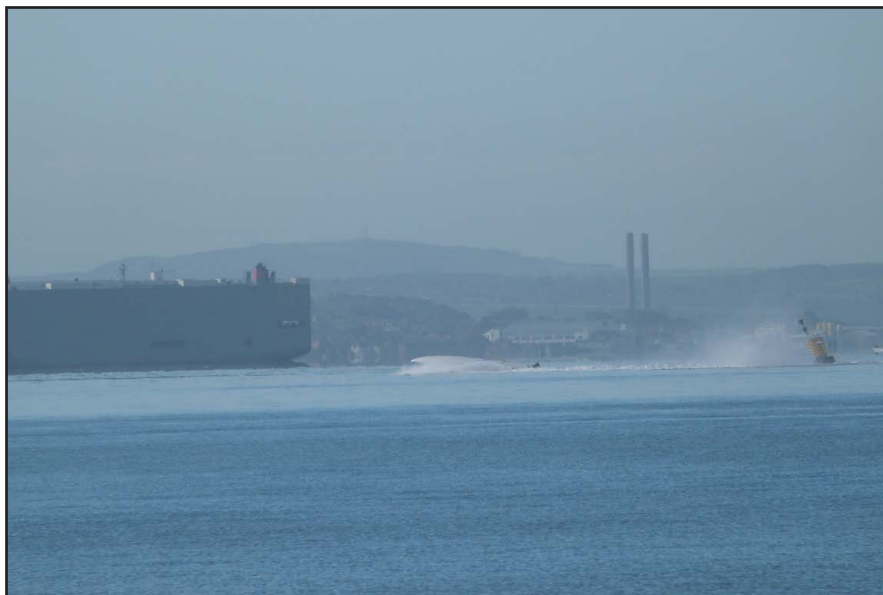
Figure 5: Accident sequence

As the additional helm was applied the boat hooked⁴ violently and turned and heeled to starboard towards the *Hamble Point* buoy. Although the driver reduced throttle speed, and eased the helm, the boat rolled violently back to port, inverted and became airborne, striking the *Hamble Point* buoy (**Figure 5**).

After the contact, still airborne, the boat began to roll to starboard until it landed heavily in the water on its port side. It then settled, inverted, on the surface of the water (**Figure 5**).

As a result of the contact, the aft hatch had sprung open allowing water to rapidly enter the inverted boat's cockpit. The driver opened the forward hatch and the co-driver pulled himself out and swam to the surface. The driver then left the cockpit via the forward hatch and confirmed that the aft hatch was open before he surfaced.

The boat was being turned to starboard still travelling at high speed while on the plane when the driver saw the fishing gear markers, and tightened the turn. It is possible that this coincided with the hull coming into contact with the wash waves seen earlier by the driver but, in any event, the lateral forces generated went beyond the capabilities of the hull, causing the keel to lose traction with the surface of the water and the boat to hook.

The transverse acceleration forces generated when the slide stopped, as the keel regained traction with the water, caused the hull to roll violently back to port, become airborne and invert. It was while the boat was inverted that it struck the navigation buoy.

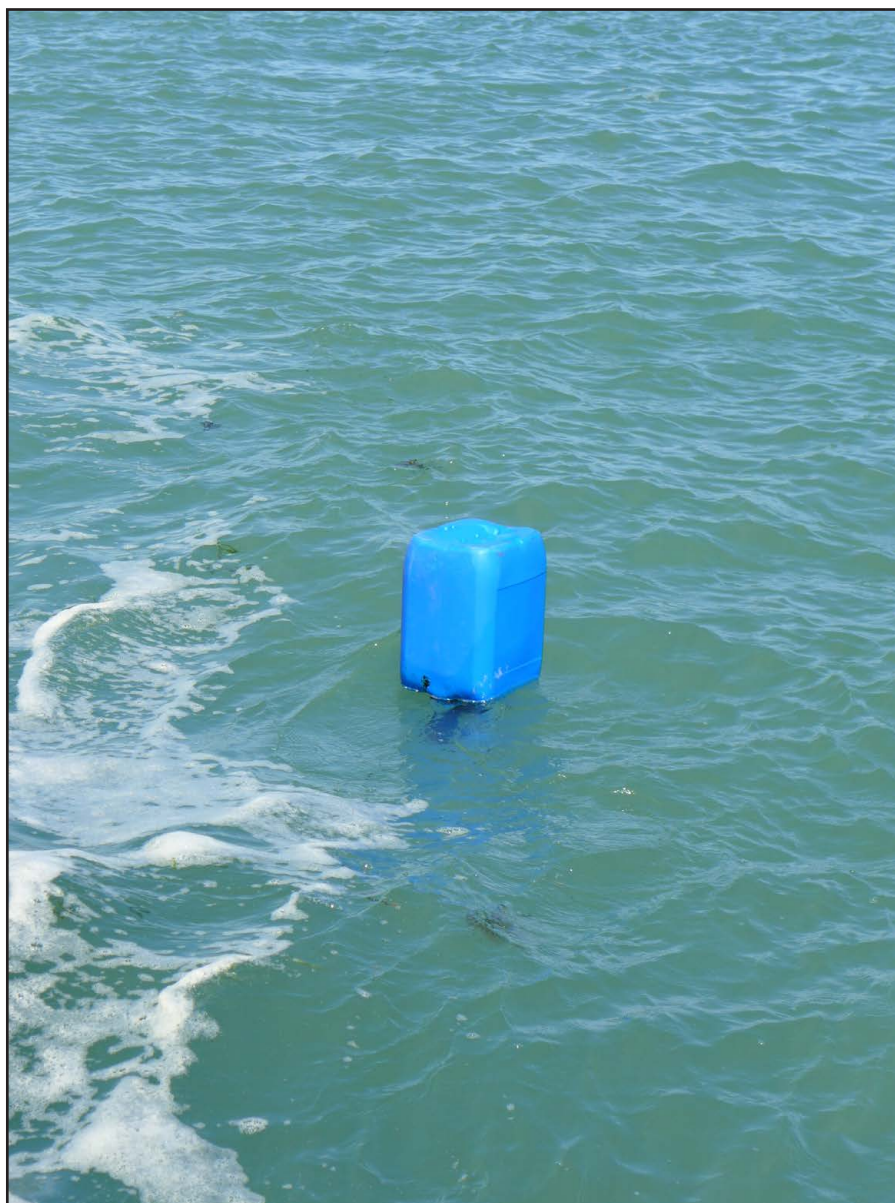
Figure 6: Fishing gear marker

The two floats seen by the driver as he turned the boat to starboard before the accident occurred, and which he thought were divers' marks, were in fact fishing gear markers that had been laid earlier that day

by a fisherman to mark a string of pots. The fisherman had operated in the same area for several years and had used similar 5 litre plastic containers to mark the location of his fishing gear throughout that time (**Figure 6**).

The markers that the driver saw did not comply with the harbour authority's requirements. Had the harbour authority been able to enforce its requirements there would have been a greater likelihood that the fishing gear would have been marked appropriately, making it significantly more visible.
