Report on the investigation into the fatal accident during
pilot transfer between

Sunmi

Patrol

River Thames, London

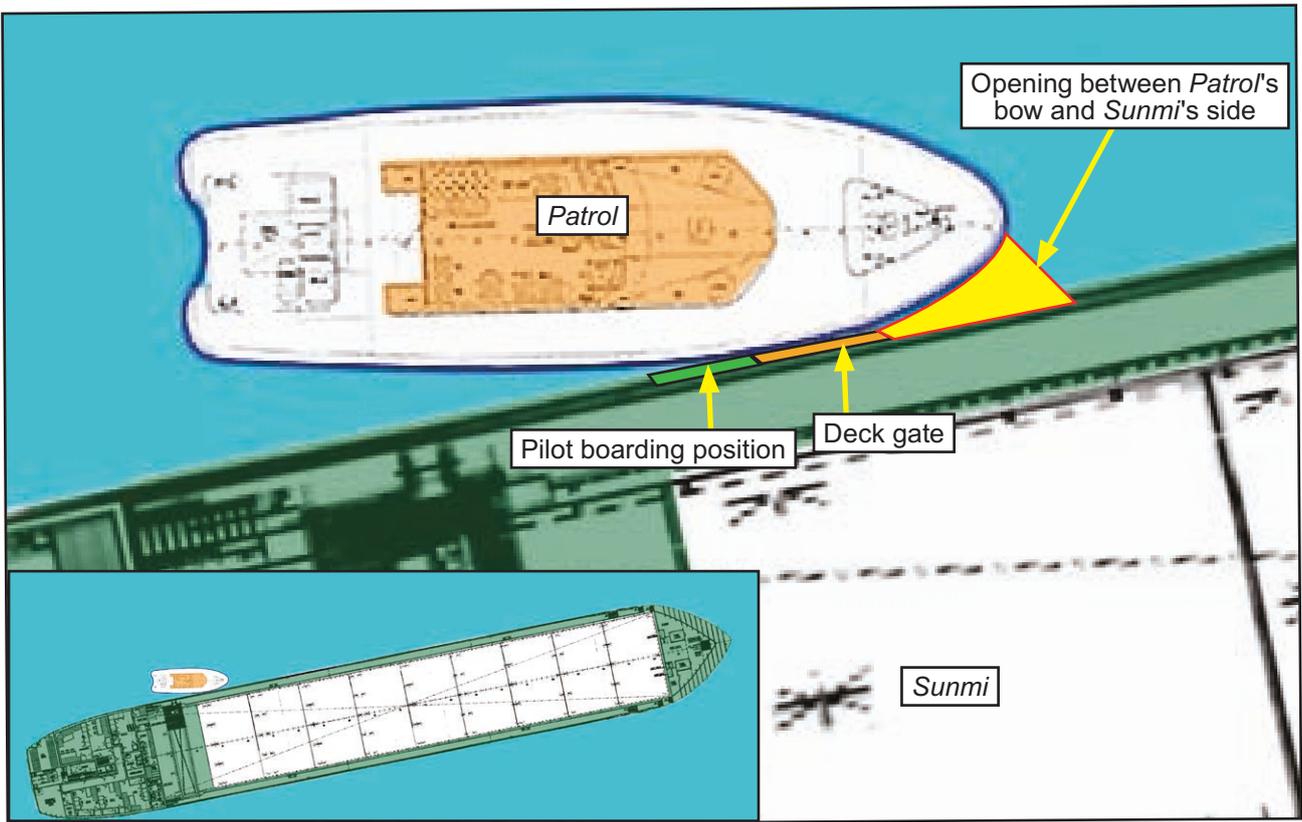
Figure 2: Patrol's position alongside Sunmi

The coxswain brought *Patrol* alongside *Sunmi* so that the launch's starboard bow was resting against the cargo ship's hull just forward of the pilot ladder in line with the deck gate in the main deck handrail, which *Sunmi*'s crew had secured open (**Figure 2**). Immediately aft of the gate, a pilot ladder had been rigged in accordance with the river pilot's instructions (**Figure 3**).

The coxswain could see that, despite the lee, there was still some swell and the difference in freeboard between the two vessels varied from 30cm to 130cm as the vessels moved up and down in the seaway.

No one saw what caused the sea pilot's fall. Both *Sunmi* and *Patrol* had altered course to provide a lee to minimise the effect of the seas in the prevailing conditions. The river pilot and coxswain had agreed to wait for the inbound ferry *Valentine* to pass clear to allow sufficient room for this manoeuvre, and to reduce the danger of its wash creating movement between the vessels. However, given that *Valentine* had only just cleared the two vessels, it is possible that its wash caused *Patrol* to drop relative to *Sunmi* just as the sea pilot was attempting to step across.

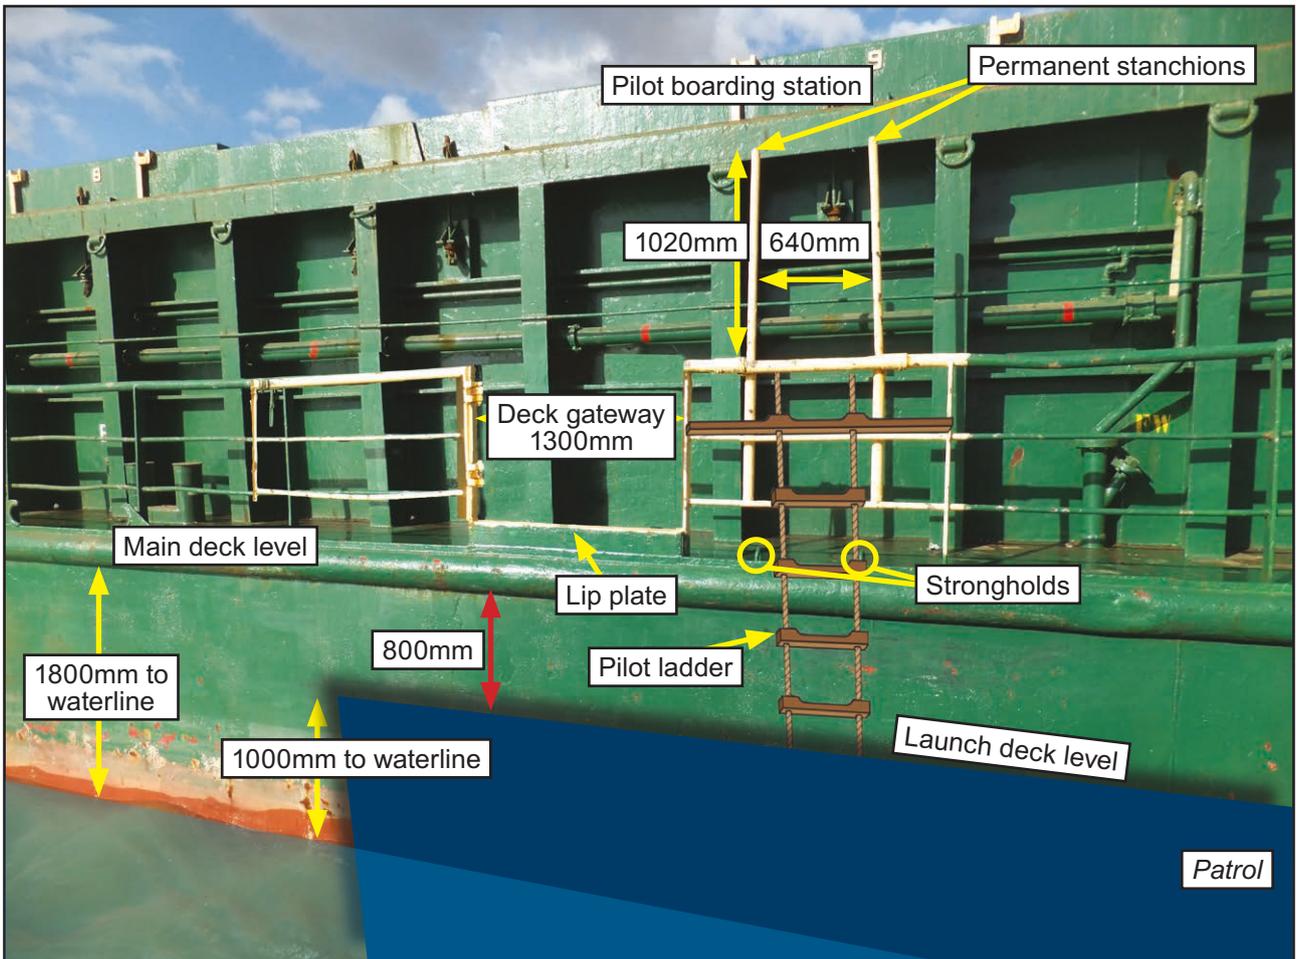
Figure 3: Representation of Sunmi's deck gate and pilot boarding arrangements

Directly in front of the sea pilot was *Sunmi's* open deck gate. On board *Sunmi* a deck rating was standing by the deck gate ready to assist the pilot if required.

Shortly before 1812 the sea pilot lifted his right foot onto *Sunmi's* deck and grasped the deck gate's uprights with both hands. He then appeared to brace himself to step up and across when the pilot launch dropped against *Sunmi* without warning, causing him to be left hanging by his arms. He was stopped from falling into the water when both *Patrol's* deckhand and *Sunmi's* deck rating grabbed hold of him. The sea pilot was then almost sitting on the pilot launch's deck with his legs between the two vessels in the 'V' formed by *Patrol's* bow and *Sunmi's* side. As the deckhand and rating struggled to lift the sea pilot onto *Sunmi*, the angle between the two vessels changed, crushing the sea pilot's legs between them. When the angle opened up again, the deck rating and deckhand manhandled the sea pilot onto *Sunmi's* deck. He was bleeding profusely from his left leg and in obvious pain.

Sunmi had two designated pilot boarding stations, one on either side of the main deck approximately one quarter of the ship's length forward of the stern. Each station had two permanent stanchions that extended 1020mm above the rail and were 640mm apart. A pilot ladder could be deployed over the top of the rail and then secured to the strongholds that were welded to the deck. Typically, a bulwark ladder (as shown in **Figure 4**) would be used to facilitate the pilot in climbing over the rail and safely onto the deck. At the time of the accident there was not a bulwark ladder rigged. When deployed for the pilot transfer with *Patrol*, the freeboard difference between the vessels was such that there was a maximum of two ladder steps showing between the two deck levels (**Figure 3**).

Immediately adjacent to the pilot ladder was a deck gate in the main deck railing designed to take the ship's gangway while alongside. The deck gate opened outboard and could be secured against the rail when fully opened, leaving an opening that was 1300mm wide. There was also a welded lip-plate across the width of the deck gate (**Figure 3**) to enable the gangway to be 'hooked' onto the deck.
