ACCIDENT REPORT

VERY SERIOUS MARINE CASUALTY

REPORT NO 2/2024

Loss of control of the powerboat *Awesome* near Little Thatch Island, British Virgin Islands on 2 October 2022, resulting in two fatalities

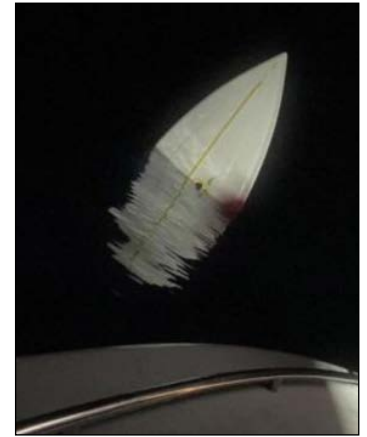
Figure 4: Awesome partially sunk, bow up

The captain of a charter boat, which was returning from the island of Jost Van Dyke with guests on board, spotted the navigation lights of two boats ahead and heard people calling from the water for the charter boat to slow down. *Awesome's* bow was still protruding from the water as the charter boat approached the scene. The captain started to help the people in the water, one of whom screamed that some of *Awesome's* occupants were still missing. A few minutes later, at about 1915, *Awesome's* bow disappeared below the surface.

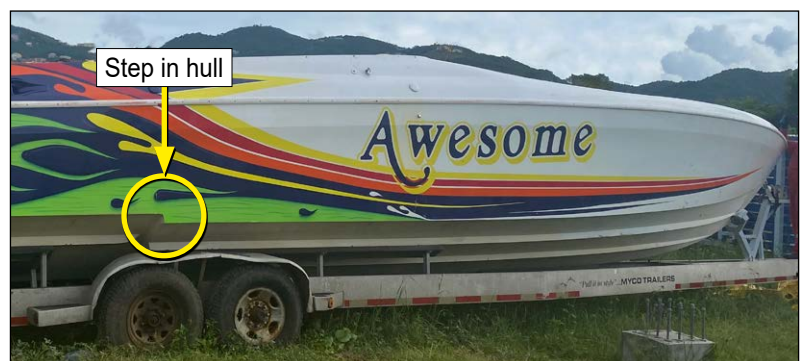
Figure 9: Pressure zone on a stepped planing hull and step in *Awesome's* hull

Awesome's hull was of an older design; modern stepped hulls are designed with the step further forward or with multiple steps to break up the pressure zones.

It is possible that the position of the step in *Awesome's* hull and the fitting of the standoff boxes, to which the stern drives were mounted, added to the severity of the accident.

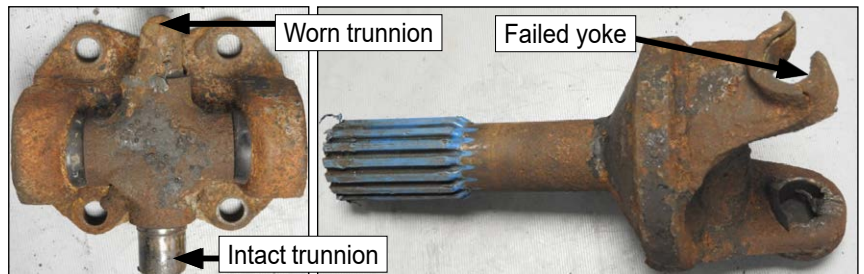
Examination of the trunnions, bearings and bearing cups has shown evidence of over loading, overheating and corrosion of the bearings. Small amounts of old grease were found in the bearing housings, but all the bearing caps showed signs of burning and the trunnions showed signs of brinelling (bruising) due to a lack of lubrication. One of the oilways that carries grease to the bearings in the failed drive shaft universal joint was partly blocked with old hard grease.

The failure was a sudden event, with no evidence of fatigue. A lack of lubrication caused a trunnion bearing to seize, leading to heavy wear of the trunnion and yoke, this is likely to have occurred over a prolonged period of time. The wear to the yoke reduced its cross-sectional area to a point where it could no longer transmit the level torque applied and suddenly failed. Examination of the remaining trunnions, bearings and bearing cups has shown evidence of over loading, overheating and corrosion of the bearings. It is considered that the failure of the bearings is the most likely cause of the incident.

When inspected, all the universal joint trunnions showed signs of overheating, wear and corrosion to varying degrees. As number three trunnion on the port drive shaft started to wear and the running clearance within the bearing housing increased, there would be a cyclic impact loading with the trunnion hitting the bearings with every rotation of the shaft. With further use, the bearing would have disintegrated, and the trunnion would have then impacted on the cast steel yoke of the joint. This repeated impact led to plastic deformation of the trunnion and the degradation of the cast steel yoke, gradually reducing its cross-sectional area. On the day of the accident the cross-sectional area of the yoke had reduced to a level where it could no longer transmit the torque applied by the engine and it failed due to brittle fracture (**Figure 10**). With the yoke no longer holding the trunnion in place, the opposite trunnion was released from its bearing and the two halves of the universal joint violently separated while rotating at around 1500 revolutions per minute. The end of the drive shaft, still attached to the gearbox, was free to flail around and impacted the steering hydraulic hose located nearby, severing it.

Figure 10: Failed port drive shaft universal joint

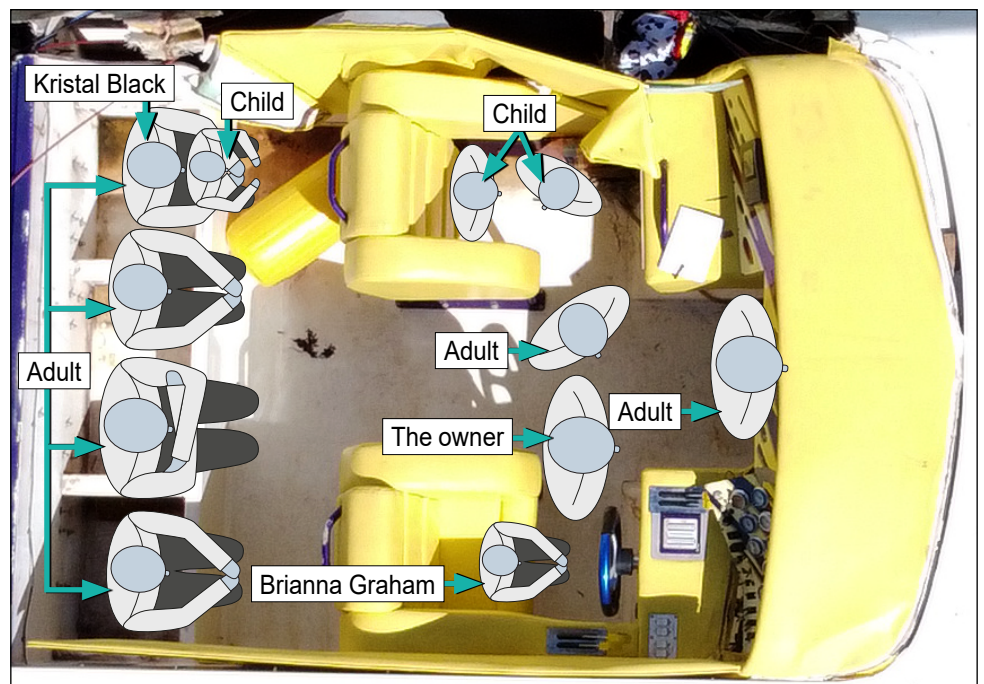
Awesome had dedicated seating for five people in the cockpit area but at the time of the accident it was travelling with eleven people on board (**Figure 11**). There were four adults seated across the three rear seats, two children occupying the port side front seat area, and three adults were standing. Few, if any, were able to access dedicated handholds or benefit from the restraining nature of the seating. Kristal was holding her young son on her lap and this would have significantly compromised her ability to hold on or brace herself. It is likely that Kristal Black impacted the handle on the back of the port side front seat with sufficient force to knock her unconscious during the accident. When her body was found by the divers, her fingernails were intact and her arms and legs were not bruised, suggesting she was unconscious when she ended up in the cabin and had made no attempt to escape before she drowned.

Figure 11: Position of *Awesome's* occupants (post-salvage representation)

As Brianna was sitting in *Awesome's* driving seat, it is likely that her head impacted the dashboard during the accident, causing the subdural haemorrhage. It is probable that the impact rendered Brianna unconscious and this, coupled with the fact that she was not wearing a PFD, contributed to her drowning.
