Vector 40R powerboat, contact with a navigation buoy

in Southampton Water

13 May 2015

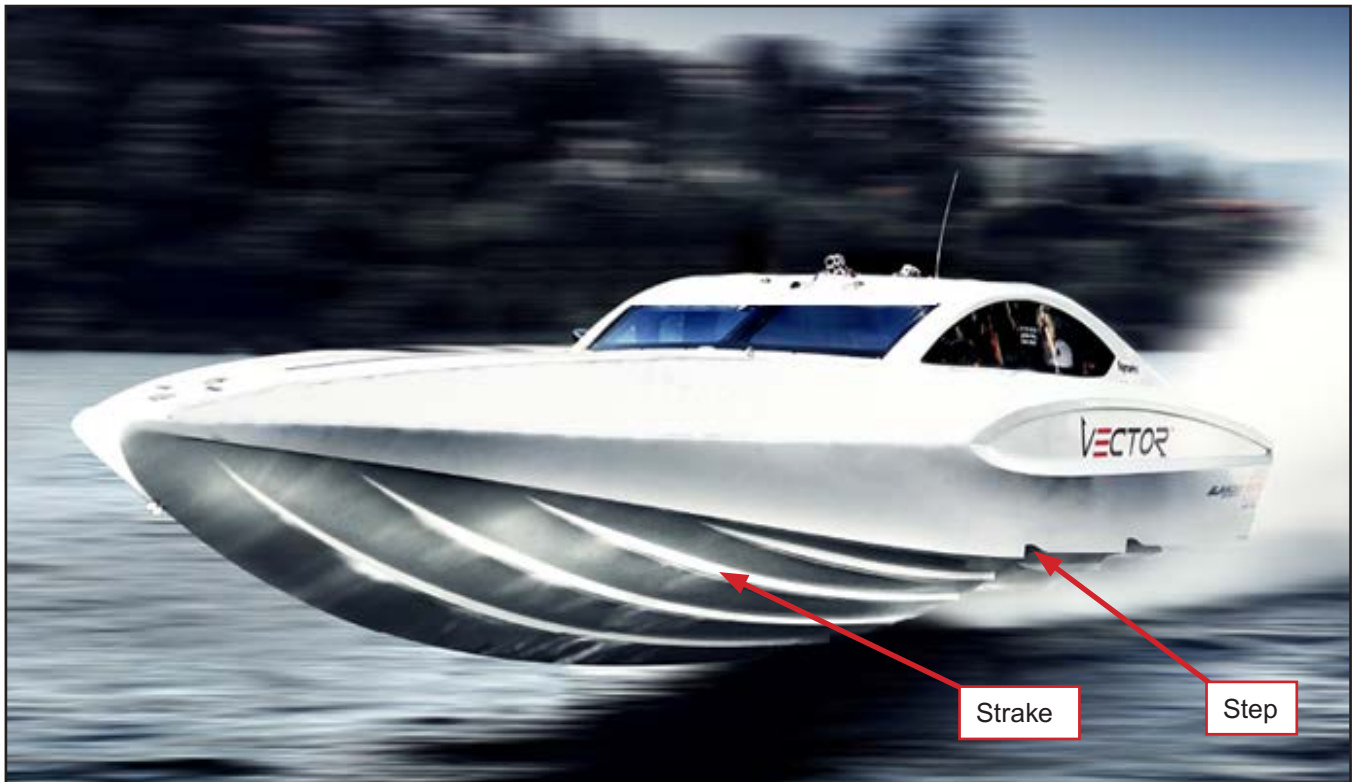
The Vector V40R powerboat involved in the accident was a fully enclosed (or canopied) 13.1m length offshore racing boat, constructed of glass reinforced plastic. Its hull was stepped and had multiple strakes (**Figure 1**). The boat was powered by two Ilmor V10 engines, each producing 540kW (725hp), which gave a top speed of over 87kts (100mph).

Figure 1: Stepped hull with multiple strakes
