Report on the investigation into the fatal accident during
pilot transfer between

Sunmi

Patrol

River Thames, London

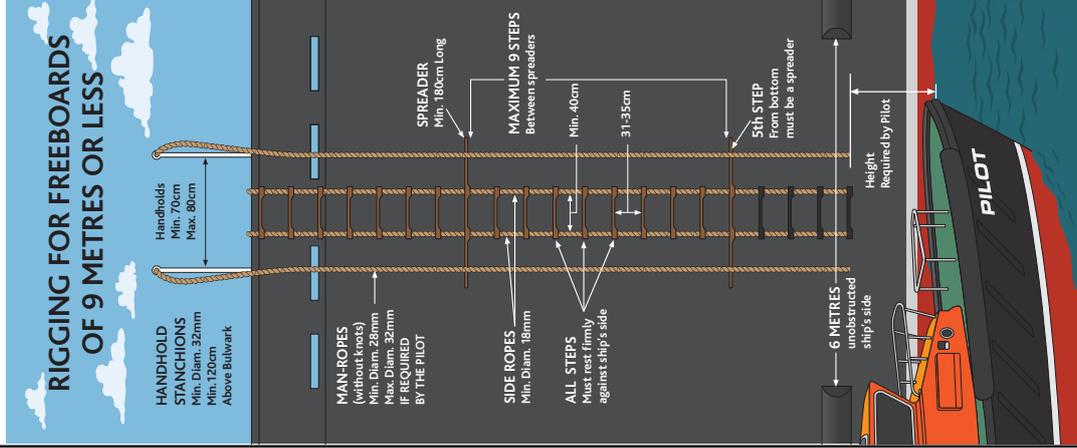
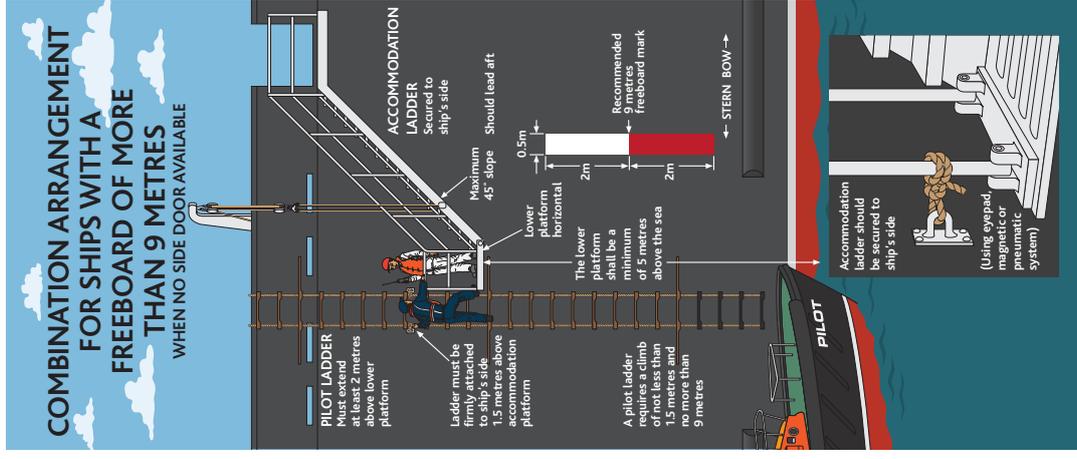
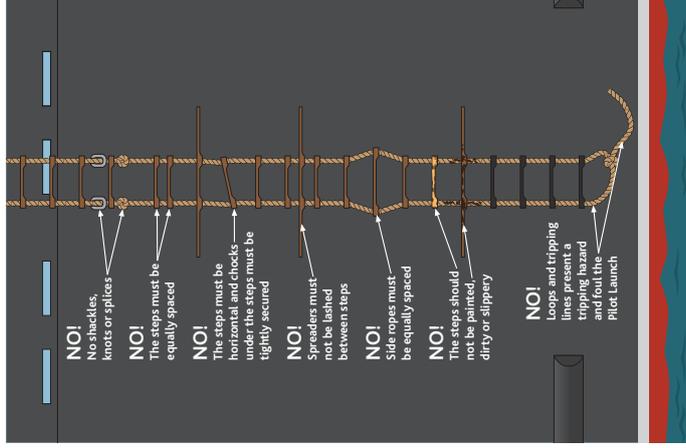
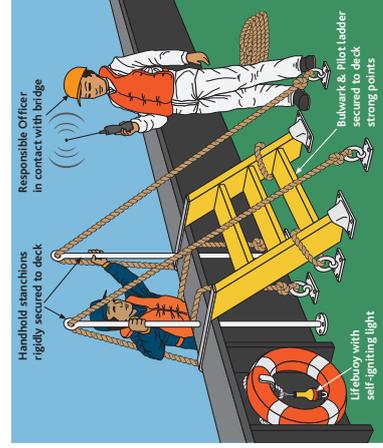
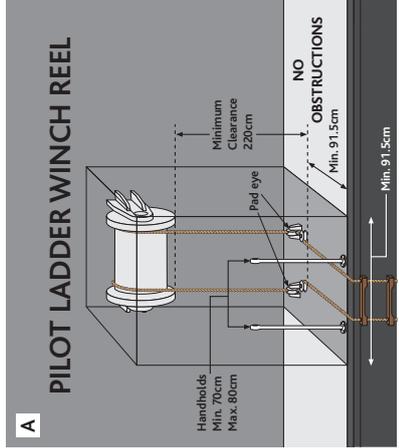
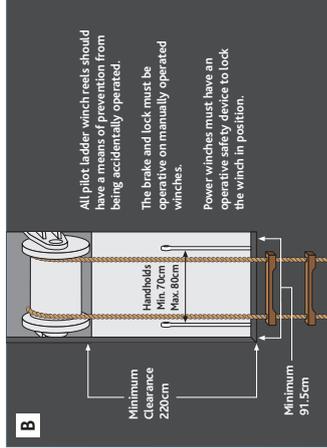
Figure 4: Required Boarding Arrangements for Pilot poster

The International Maritime Pilots' Association (IMPA) produced a 'Required Boarding Arrangements For Pilot' poster (**Figure 4**), which details the requirements of SOLAS and IMO Resolution A.1045(27). The poster does not depict the amendments in Resolution A.1108(29), but it does show the requirement for additional equipment such as lifebuoys and a bulwark ladder in addition to a responsible officer, who has a means of communication with the bridge. The poster is not required to be displayed or carried on board merchant ships and it was not displayed on *Sunmi's* bridge.

The IMPA '*Required Boarding Arrangements for Pilot*' poster (**Figure 4**) provided a clear and easy to understand reminder of the correct procedures to be followed for safe pilot transfer, and was widely used on vessels as a guide for crews. The poster was not required to be posted or carried on board vessels and was not displayed on board *Sunmi*. However, since the poster did not show the amended arrangements for deck gates promulgated in IMO Resolution A.1108(29), it is unlikely to have prompted any change to the boarding arrangements on *Sunmi*, even if it had been displayed.
