ACCIDENT REPORT

VERY SERIOUS MARINE CASUALTY

REPORT NO 2/2024

Loss of control of the powerboat *Awesome* near Little Thatch Island, British Virgin Islands on 2 October 2022, resulting in two fatalities

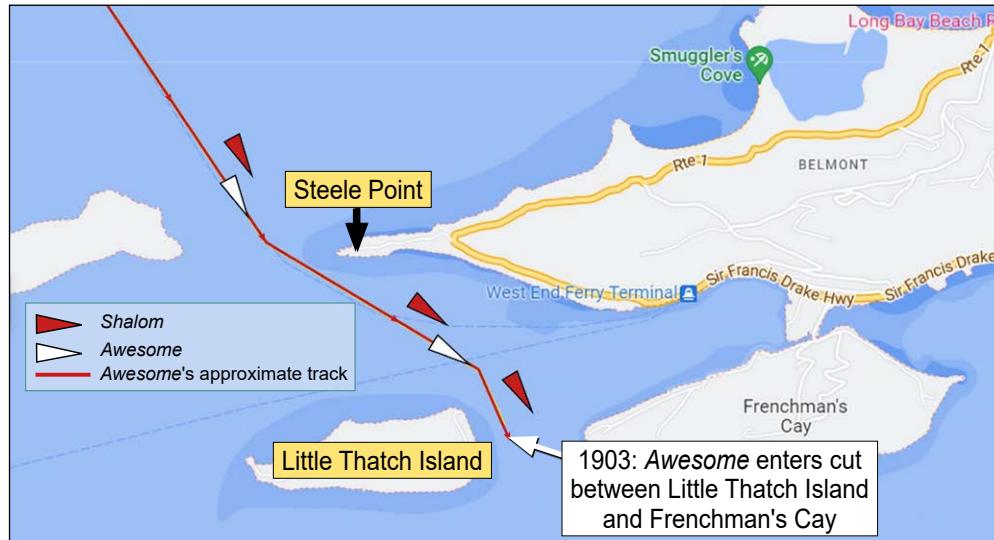
Figure 3: Awesome's approximate track

Awesome was travelling at about half speed as the two boats headed towards Steele Point (**Figure 3**) in the dark. At 1903, as *Awesome* entered the cut between Little Thatch Island and Frenchman's Cay, it turned very sharply to starboard, inducing a lateral slide, and tripped¹ to port violently, resulting in the ejection of ten of the eleven occupants. *Awesome* then reared up into a vertical position, with its bow in the air, landed back in the water on its transom, and then started to sink. The air trapped in the forward cabin briefly held the boat afloat vertically (**Figure 4**).

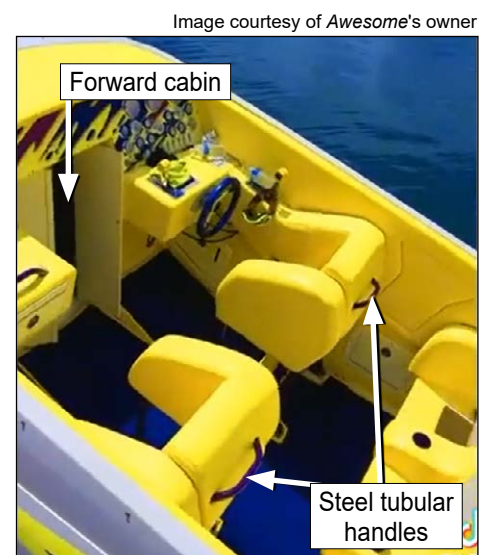
Figure 6: *Awesome*'s general seating arrangement

Awesome had seating capacity for five people. Two seats were located forward in the cockpit area, one on the port side and the other on the starboard side, which was also the driver's position. A further three seats were fitted in the aft of the cockpit, across the width of the boat (**Figure 6**).

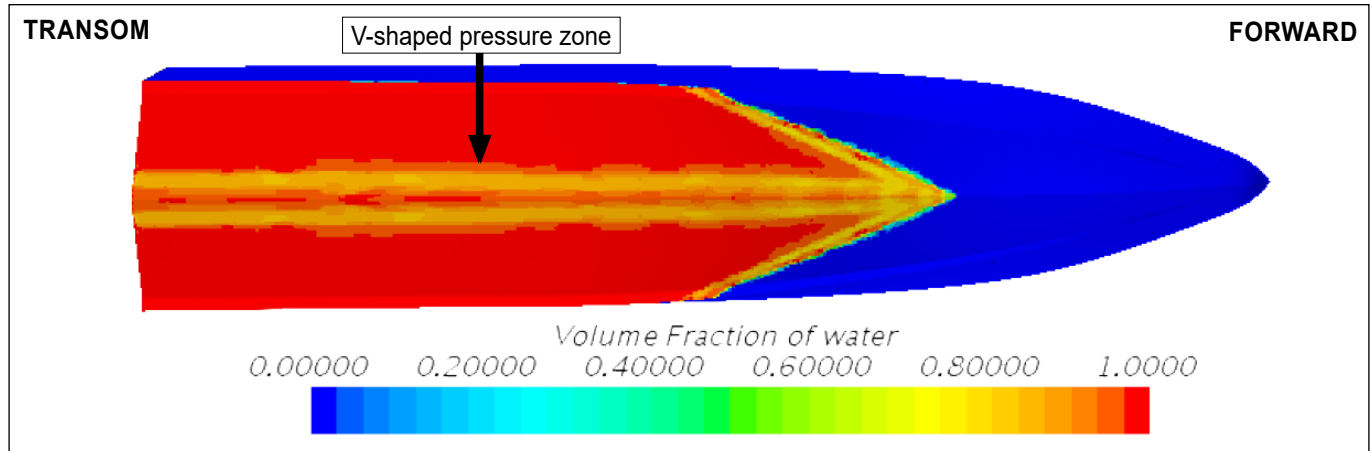
Figure 8: Pressure zone on a standard planing hull

from the transom (**Figure 8**). The incorporation of a step into the hull allows air to be trapped between the hull's surface and the water, reducing drag. A stepped planing hull creates a second V-shaped pressure zone forward of the step (**Figure 9**). The two V-shaped pressure zones meant that *Awesome* lifted with less hull angle and moved flatter through the water. Additionally, the transmission of the drive force from the propellers to the water was done at a more favourable angle, increasing the boat's efficiency and speed.

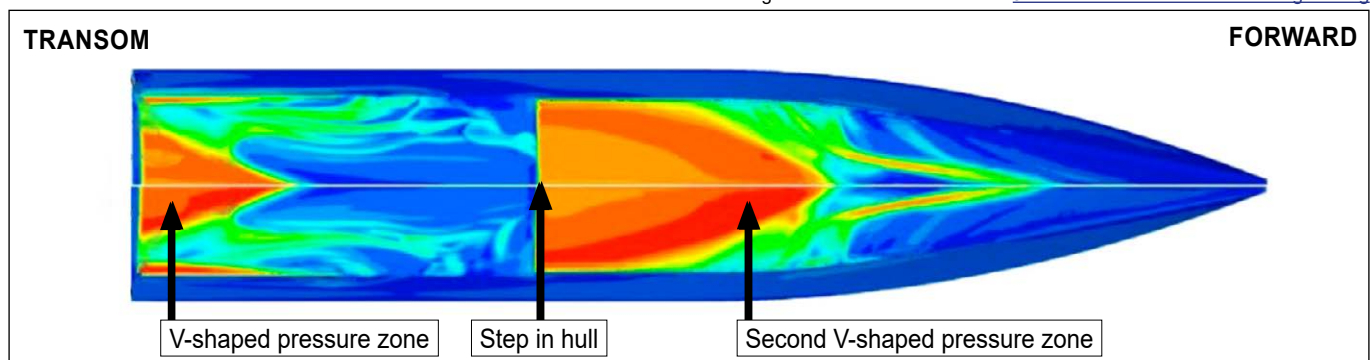
Figure 9: Pressure zone on a stepped planing hull and step in *Awesome's* hull

Boats with stepped hulls generally have less directional stability than those with standard planing hulls due to the shielding effect the step has on the water flow over the hull's surface. *Awesome*'s directional stability relied on the skegs on the drive units (see **Figure 5**) and this would have been lost when the drives locked over to starboard and the skegs were working to turn the boat. The reduced immersed area of the hull aft meant that the turning leverage of the drives and skegs would have increased, making the hull react faster to the effect of the locked over drives.
